## BRADHAM-BROOKS NW BRANCH LIBRARY RE-ROOFING AND WATER INTRUSION REPAIRS

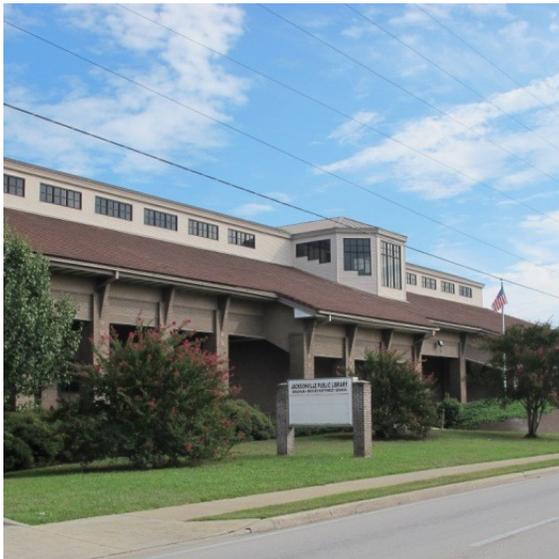
**BEFORE**

The 25 year old library was experiencing water intrusion at the clerestory windows and at intersections of clerestory walls with the sloped barrel tile roofing. The pressure treated nailers for attaching the concrete barrel tile roofing had deteriorated in numerous spots resulting in the slippage of numerous tiles.
